Inspection Report

03.25.2020

Advantage Inspection Services

615 Sienna Way
Summerville SC 29486

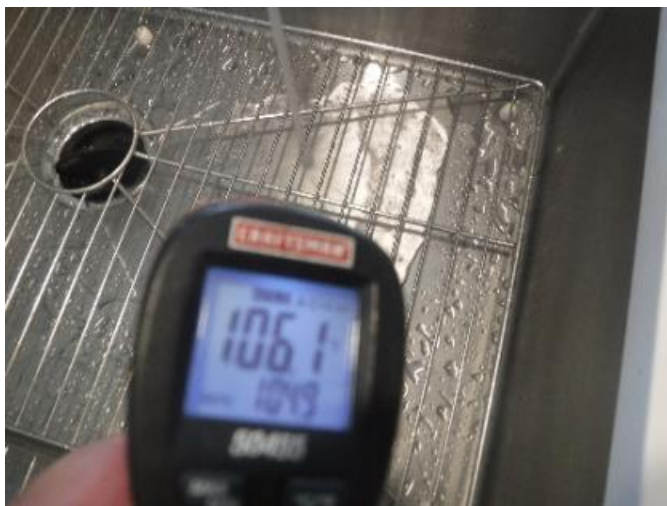
An acceptable water temperature of 106.1 degrees was taken at the kitchen sink with the dishwasher running at the inspection.

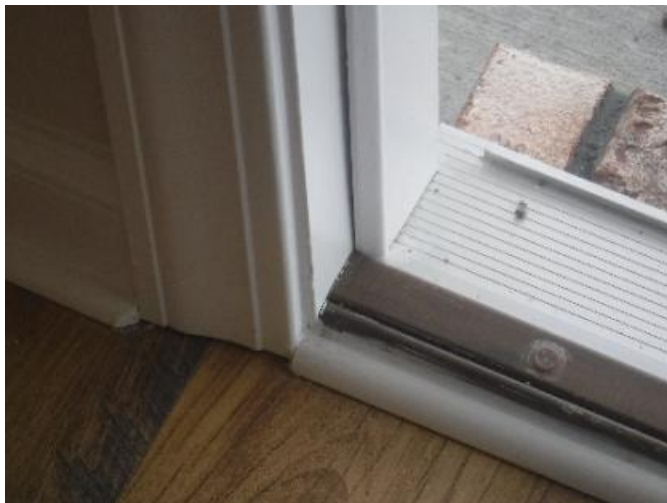
Have builder install the missing bottom corner pads on all 3 exterior doors as needed

1. Have builder install the trim around the left side top window and replace any damaged siding to prevent water/damage to occur as soon as possible
2. Have builder install the missing bottom corner pads on all 3 exterior doors as needed

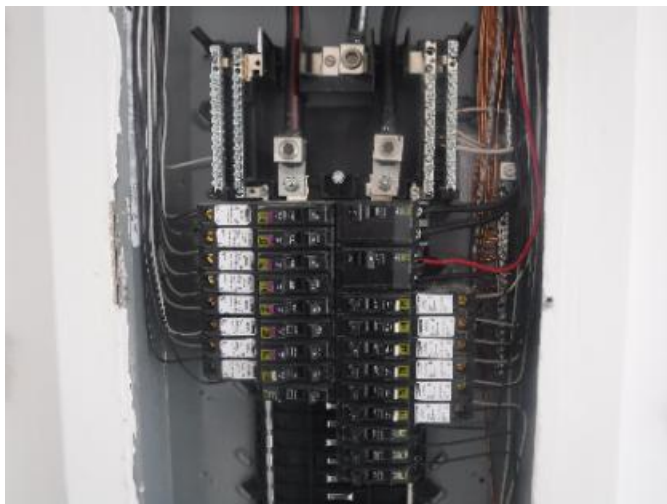
The main electric shut off was located on the exterior next to the meter and 200 Amp Aluminium service with ARC breakers was noted in the garage. panel was fine at time of the inspection.

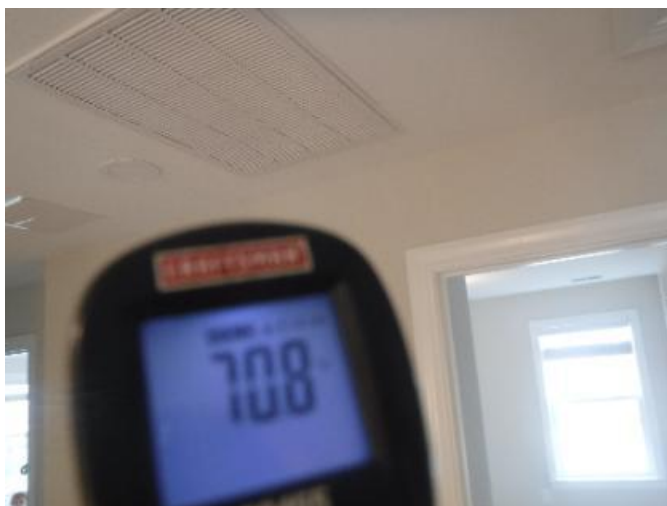
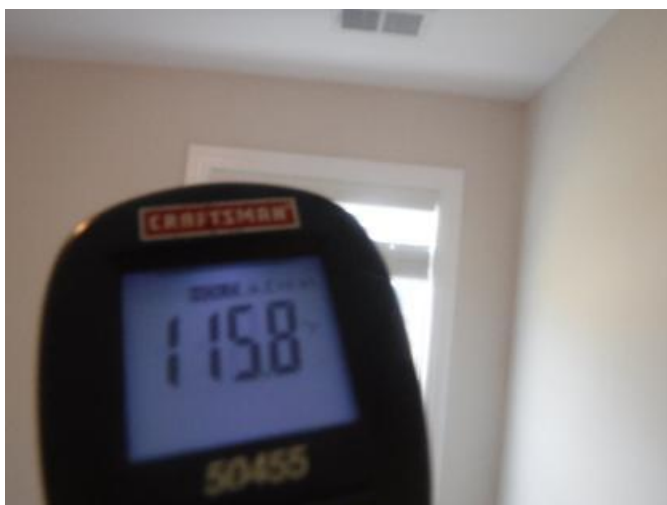
The temperature output with respect to return temperature on the furnace was within normal limits. 70 degrees at the return grill and 115 degrees at the supply vent

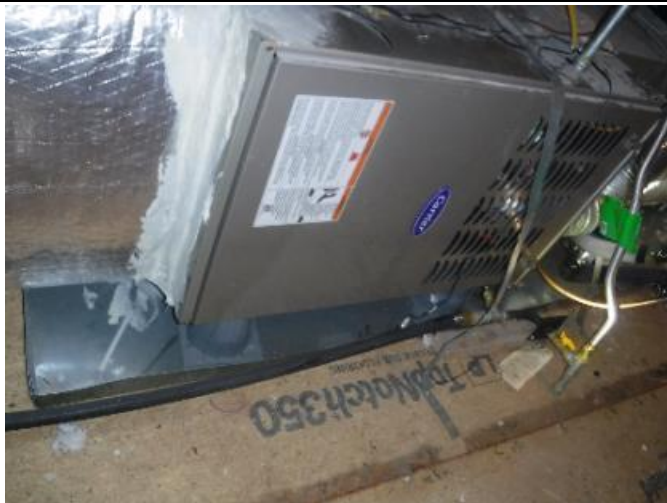
Reference photo of the attic gas a/c unit and drain pan with no water in pan at time of the inspection

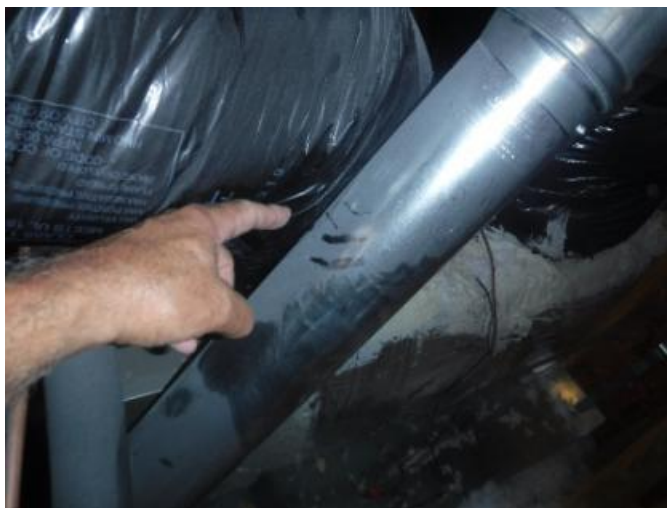
At unit in attic

Have builder secure the a/c duct that was against the metal flue for safety and also trim the roof tar paper at the roof where pipe is also touching. Minimum of 1" clearance for safety

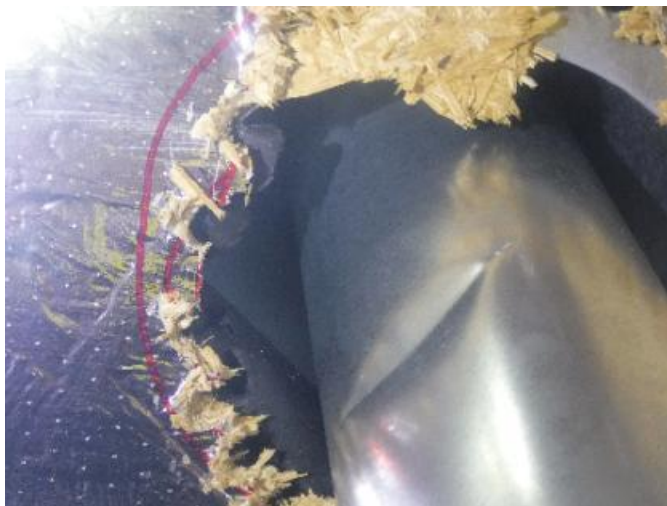
Roof area in attic

Have builder secure the a/c duct that was against the metal flue for safety and also trim the roof tar paper at the roof where pipe is also touching. Minimum of 1" clearance for safety

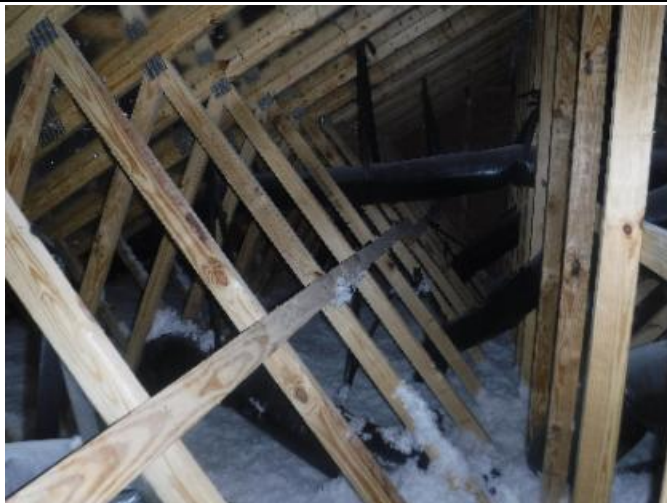
Reference of the trussed roof system,blown R-30 insulation and the a/c duct work at the inspection.

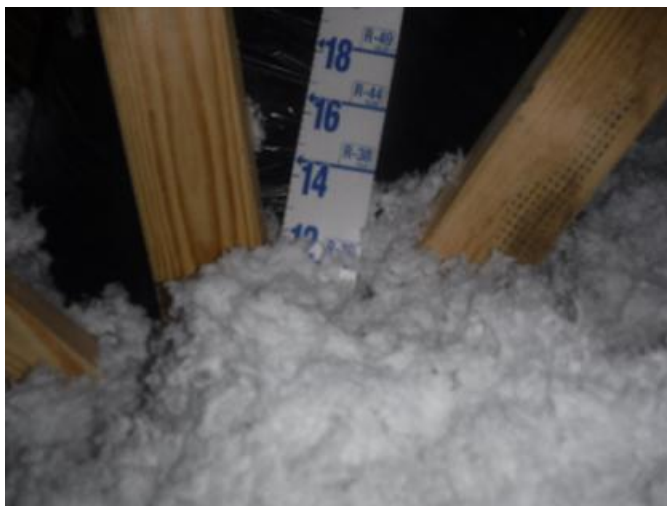
13.5 +/- inches of blown fiberglass insulation is present in attic and is rated at R-30+/- . This meets current standards

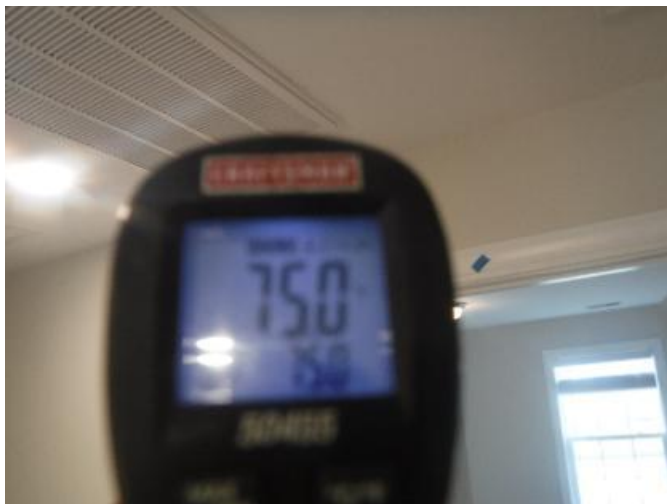
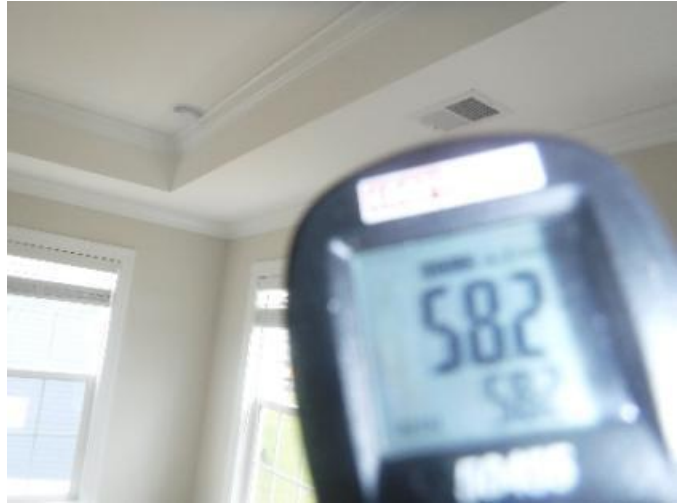
The temperature output with respect to return temperature on air conditioner was within normal limits - unit working fine at time of inspection. 75 degrees at the return grill and 58 degrees at the supply vent

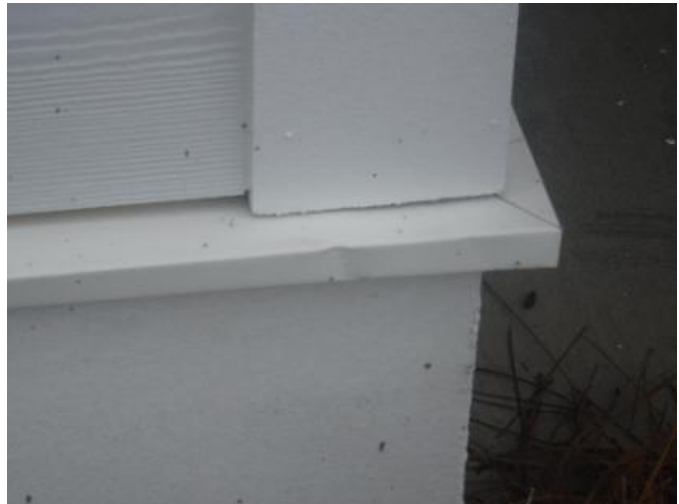
Have builder replace the damaged metal on the right side of the garage at the corner as needed (low at 18 inches off ground)

6. Have builder replace the damaged metal on the right side of the garage at the corner as needed (low at 18 inches off ground)
7. Have builder seal all exterior penetrations to prevent water from entering.

Have builder replace the damaged metal on the right side of the garage at the corner as needed (low at 18 inches off ground)

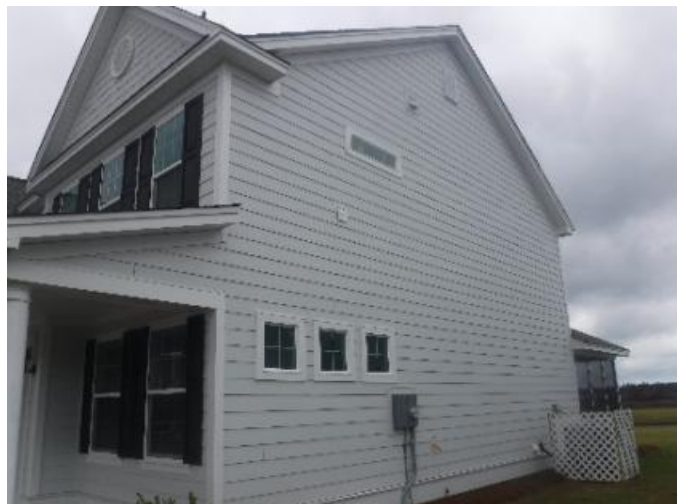
Reference of the right side of the house, underground electric, main electric shut off and the A/C unit

Have builder seal all exterior penetrations to prevent water from entering.

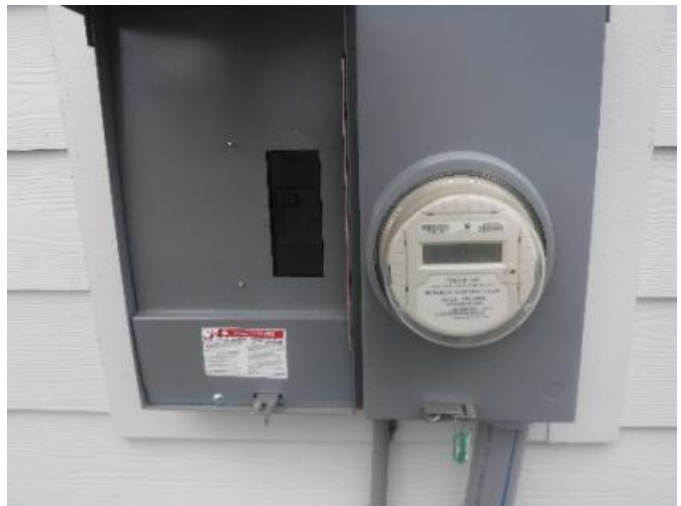
The main electric shut off was located on the exterior next to the meter and 200 Amp Aluminium service

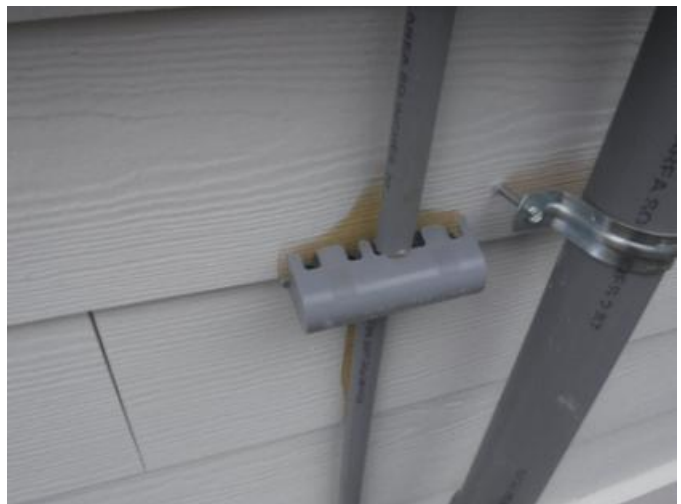
Right side

Have builder finish all exterior painting on the trim as needed, some areas appear to only have 1 coat

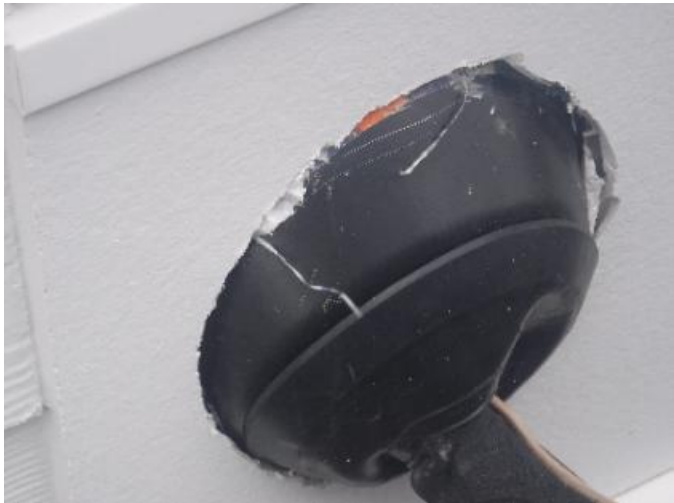
Have builder seal all exterior penetrations to prevent water from entering.

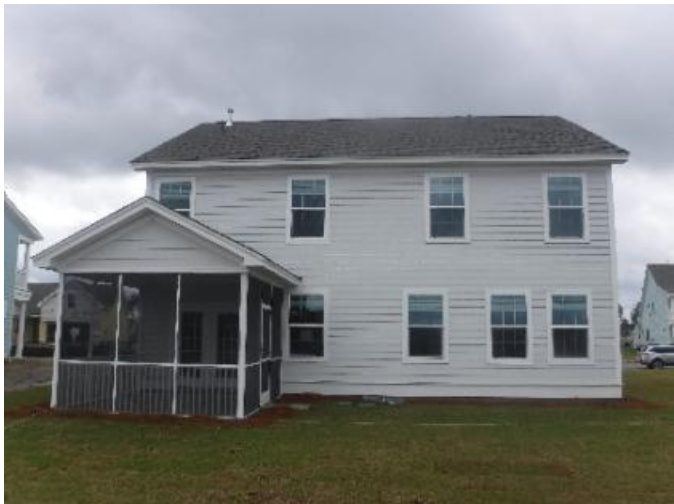
Photo of the rear of the house and screen porch

Have builder remove the concrete from the rear screen porch door that splashed on when pouring pad. If not acceptable to buyers door will need to be replaced.

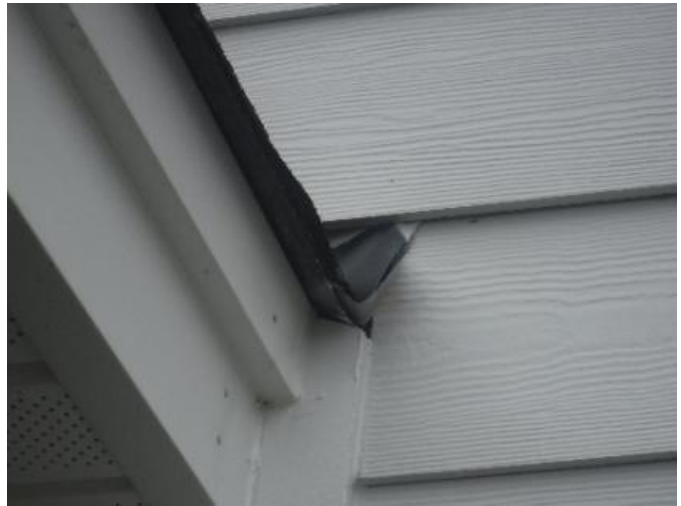
Good construction practices of kick out flashing at eaves.
Majority of flashing was not visible for inspection due to finished products being installed

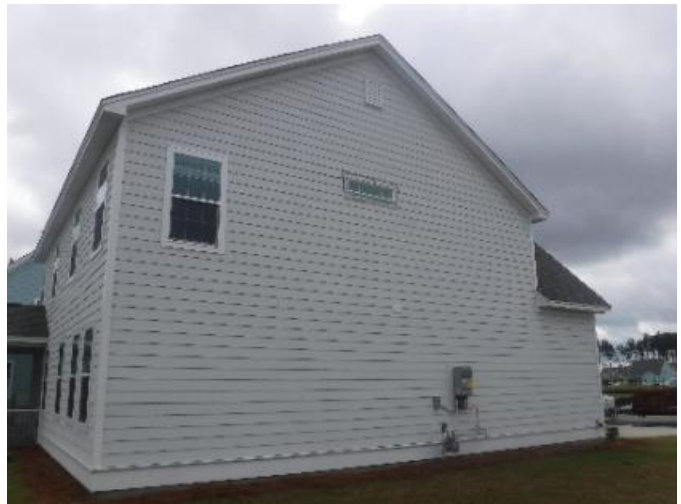
Reference photo of the left side of the house, gas meter and water heater

Have builder install the trim around the left side top window and replace any damaged siding to prevent water/damage to occur as soon as possible

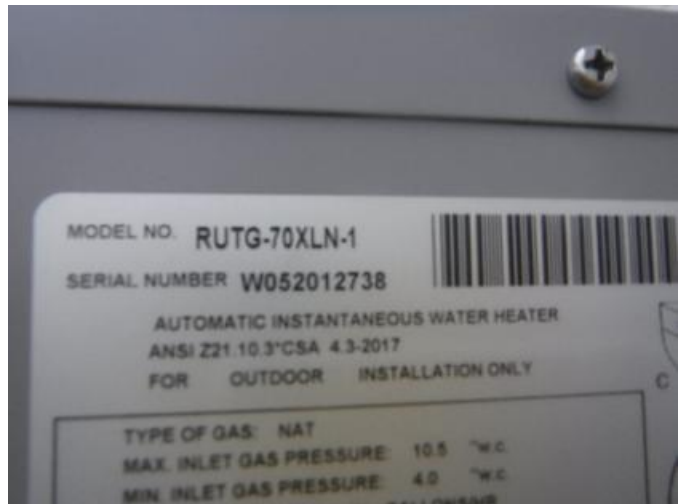
Water heater info for Rudd tank less unit

MODEL NO. RUTG-70XLN-1

SERIAL NUMBER W052012738
